CASE STUDY

University
Hospital
Monklands

**BOILERHOUSE
REPLACEMENT
FUEL TANK**

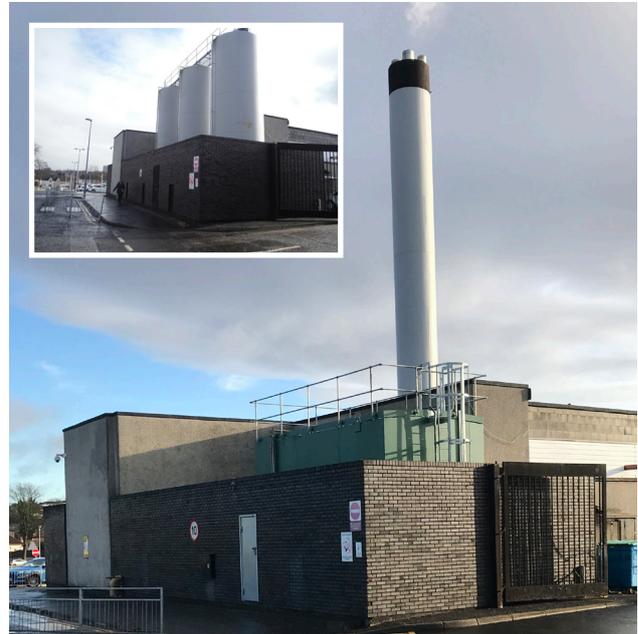
Above: The new tank in position, and inset, the previous 3 tanks.

In February 2019, Merkland Tank began the 3-month long process of replacing three existing 50,000 litre oil tanks at University Hospital Monklands with a single, bespoke 56,000 litre steel bunded tank. The new oil tank would provide an essential back-up / dual feed for the hospital's boilers and small back-up generator.

The project saw Merkland Tank deliver a complete turnkey solution on behalf of NHS Lanarkshire's Principal Supply Chain Partner, GRAHAM Construction Limited. Merkland Tank designed the new totally enclosed steel bunded unit (in conjunction with HKA), emptied, cleaned and removed the existing three cylindrical steel tanks and then installed the new unit.

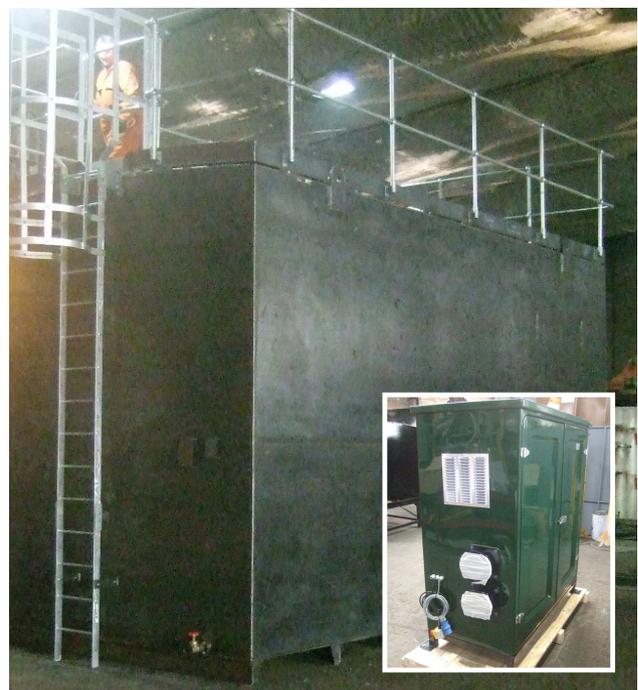
Below: The new tank during manufacture, and inset, the fuel polishing unit which will clean the fuel in the new tank at regular intervals to prevent system contamination.

The new unit was designed and certified to OFS T200, complying with the Water Environment (Controlled Activities) Regulations 2011 (as amended) (CAR), the Control of Pollution (Oil Storage) (England) Regulations 2001 and to SEPA & EA Guidelines, generally to BS799-5:2010. It was also built with an intergrated fuel polishing unit to prevent fuel contamination within the tank.
