# NEWSLETTER

## What's new at Merkland Tank?

## SPOTLIGHT ON...WESP PIPE CLEANING - NEW CASE STUDY!

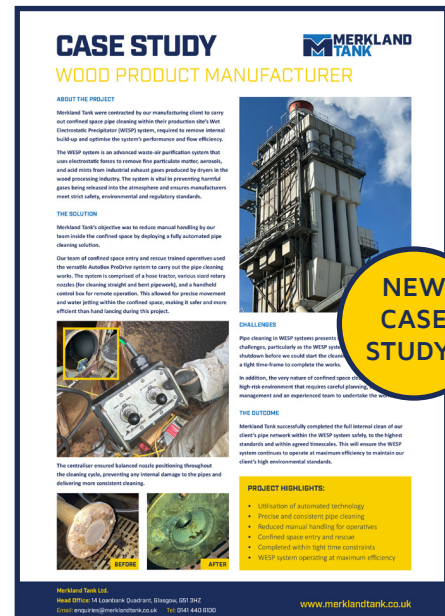
Merkland Tank recently carried out confined space pipe cleaning within our manufacturing client's Wet Electrostatic Precipitator (WESP) system. This regular maintenance work is required to remove internal build-up within the pipes and optimise the system's performance and efficiency.

One of our key objectives was to reduce manual handling by our team inside the confined space, so we opted to deploy a fully automated pipe cleaning solution. Our team of confined space entry and rescue trained operatives used the versatile and remote-operated AutoBox ProDrive system to carry out the pipe cleaning works. This allowed for precise movement and water jetting within the confined space, making it safer and more efficient than hand lancing for this particular project.

We successfully completed the full internal clean of our client's pipe network within the WESP system safely, to the highest of standards, and within agreed tight timescales to minimise production downtime.

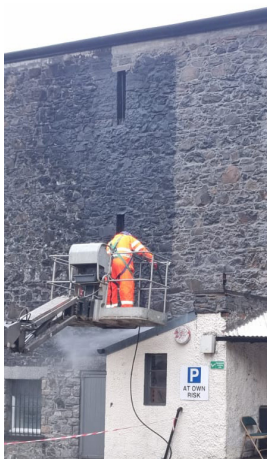
Our team carried out high-level cleaning of the distillery's exterior stone walls to remove the black staining caused by a natural fungus that feeds off ethanol vapours. It's linked to the Angel's Share - the 2% of alcohol that evaporates annually through the pores of the wooden casks during the maturation process.

While the staining is not significantly harmful, regular cleaning and removal prevents any unwanted build-up that might lead to degradation of the buildings, it reduces local environmental impact, and of course, enhances the aesthetic of the building for visitors.

We gave the building a 3000psi hot wash and our experienced, fully trained operatives safely accessed the hard-to-reach areas using a mobile elevating work platform (MEWP).
